Forestry Note:

STABILIZING GULLY WALLS AND BOTTOMS WITH DEFLECTORS AND TREES

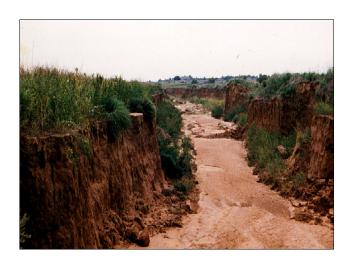
Figure 1. Large gully near Grandfield in Tillman County. Photo taken in 1990 before installation of the main drop-structure. The arms of this gully below the channel drop-structures range from 15 to 30 feet in depth and 50 to more than 300 feet in width.

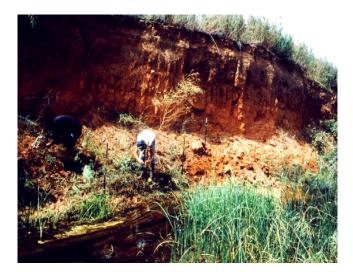
Figure 6a. Installation of deflector on the Stinson Creek gully, immediately above the Figure 2 location

Each deflector consists of a 4-foot by 16-foot cattle panel, held in place by four posts. Most deflectors were installed with 6½-foot steel T-posts (Figures 6a and 6b).

The panels were installed at an angle of about 15 degrees from the gully wall. Where a gully-wall toe exists, the deflector should be placed on the toe. The deflectors in Figure 6b were spaced at 18 feet center to center. Spacing depends on the

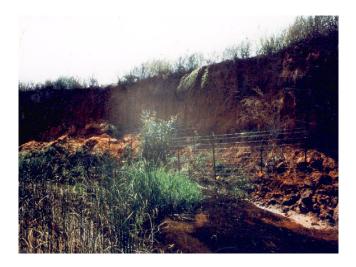
Figure 6b. Deflectors installed on the Stinson Creek gully. These are replacements (see Figure 8g). These deflectors are spaced 18 feet apart, center to center.
