Forestry Note:

LOW-COST GULLY CONTROL USING FIBER MAT AND TREES

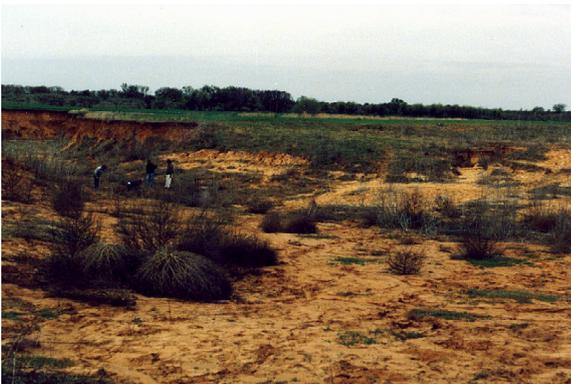
These small gullies developed on sloping, deep, sandy subsoil on an eroded area shaped during the construction of the dam and pipe drop-structure on a large gully system near Grandfield. Figure 1 is a photo of the gully area before treatment, taken from the top of the drop-structure dam. The first gully treated is in the right center of Figure 1. The second gully is near the center of the photograph.

Figure 1. Small gullies in Tillman County before treatment, seen from the top of the dam

Figures 10a and 10b are views of the gully area in the second and sixth growing seasons, respectively. Views are from the top of the dam, the same viewpoint as in Figure 1.

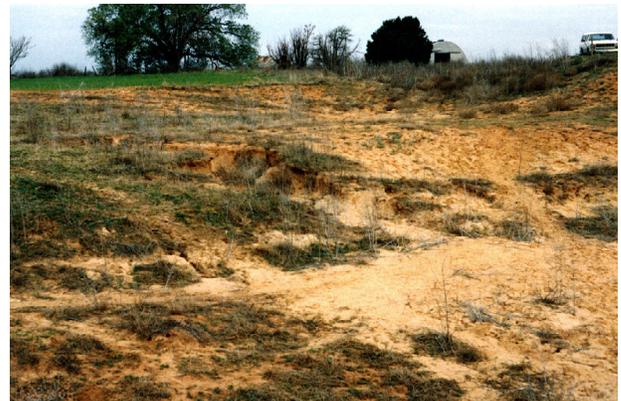
This gully is about 70 feet long and empties onto a flat area (Figure 2). The slope is steep. The site is very sandy and dry, with low tree-growth potential. The watershed area is less than one acre.

Figure 2. The first gully before treatment

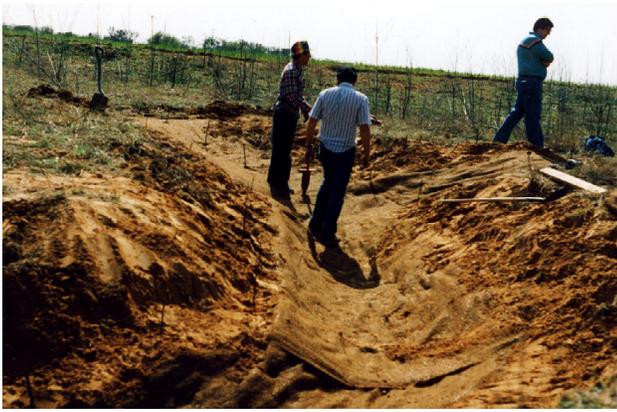
The treatment consisted of shaping the gully with hand labor, laying out and anchoring the fiber mat and planting black locust seedlings through the fiber mat and on the surrounding area (Figure 3). The fiber mat was anchored with heavy wire pins supplied by the manufacturer.

Figure 3. Planting seedlings after gully shaping and placement of fiber mat

Fiber mat products made of a variety of materials, including straw, excelsior and coconut fibers, are available for erosion control use. The fiber material is stitched between sheets of synthetic netting. For this project, coconut fiber mat was selected because of its durability. The fiber itself lasts from four to six years, and the netting somewhat longer, which helps stabilize the site while vegetation becomes established.

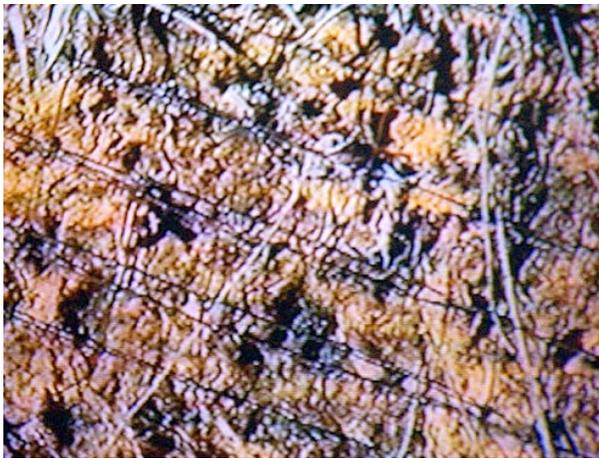
Figure 4. A close-up view of the fiber mat netting in its sixth year of service

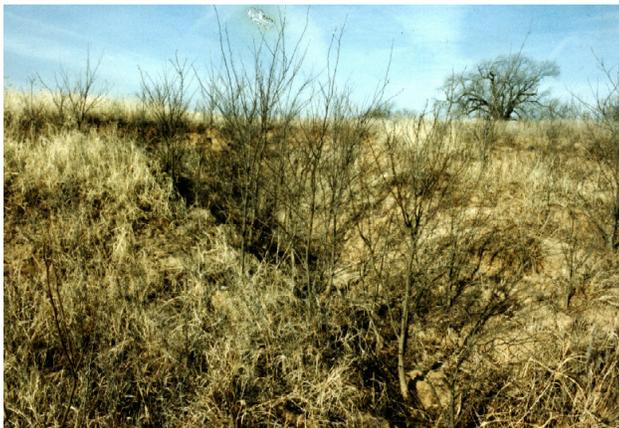
Figure 5. Vegetated condition of the gully in the winter following the fourth growing season

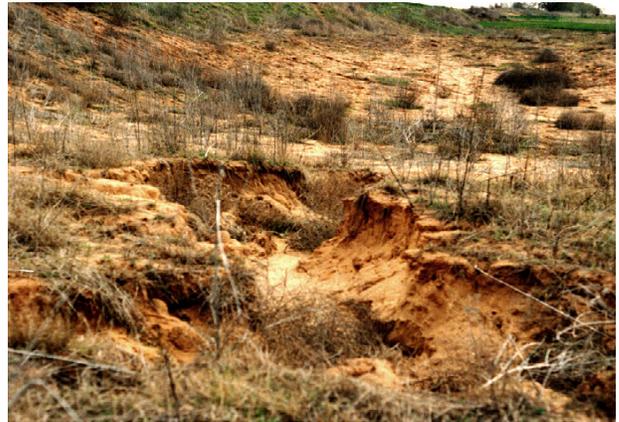
Figure 6 shows the second gully prior to treatment. Although the soil is also deep and sandy, the site is more favorable to vegetative growth because it is flatter and receives runoff from the slopes. The drainage area is about one acre.

Figure 6. Pretreatment conditions of the second gully

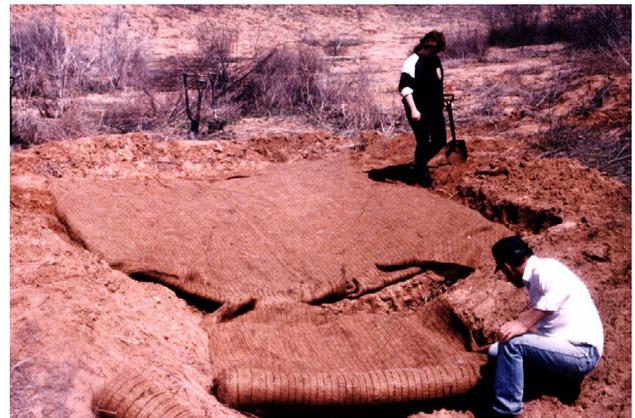
The shallow headcut was shaped manually with shovels. Trenches about one foot deep were dug for burying the edges of the fiber mat (Figure 7a). Shaping and fiber mat application

Figure 7a. Placing fiber mat in the second gully

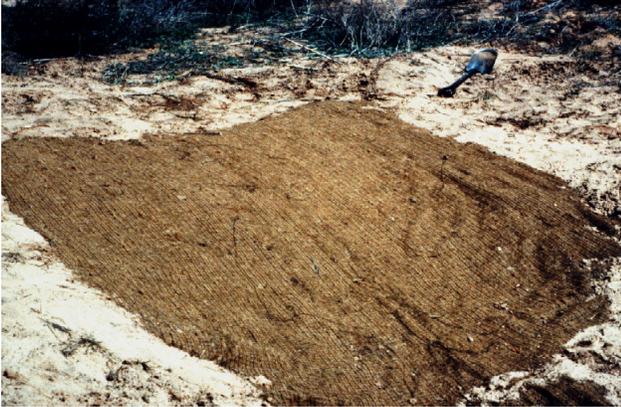
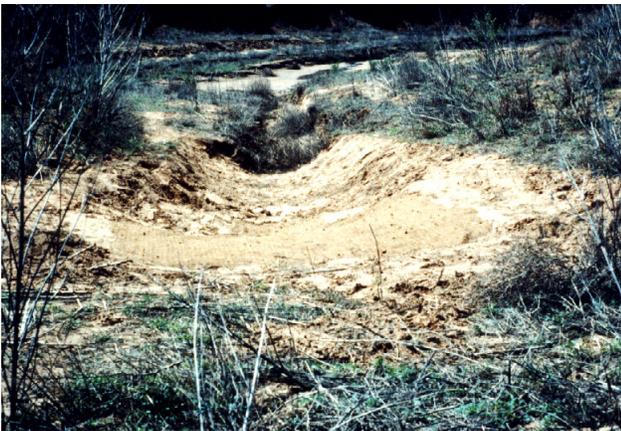
were limited to the headcut area (Figures 7b and 7c). Black locust seedlings were planted through the fiber mat on a 3-foot by 3-foot spacing.

Figure 7b and 7c. Views of the completed fiber mat application looking upslope (Figure 7b above) and down slope (Figure 7c below)

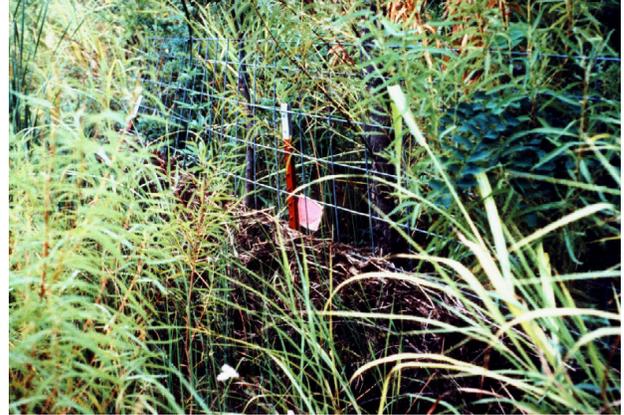
Figure 8. Cattle panel structure with trash accumulation and vegetation in the second growing season after treatment

To stabilize the main part of this gully, we installed a structure consisting of an 8-foot section of cattle panel, supported by steel posts (Figure 8). The entire area was planted with black locust seedlings on a 5-foot by 5-foot spacing.

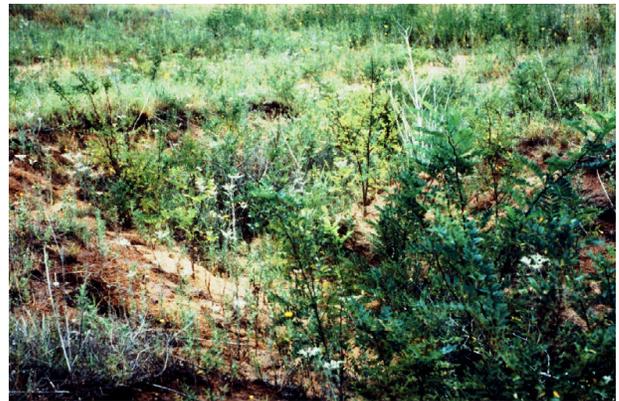
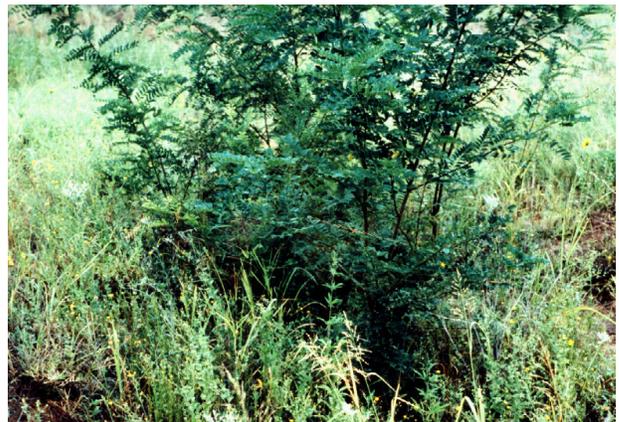
Figure 9a and 9b. Views of vegetative growth on the treated headcut site in the second growing season (Figure 9a above) and fourth growing season (Figure 9b below) following treatment

Post-treatment growth of the black locust seedlings and grass on this site was moderate. Figures 9a and 9b are views of the headcut site in the second and fourth growing seasons following treatment. Figure 9c is a view of vegetative growth at the cattle panel location on the gully in the winter following the fourth growing season.

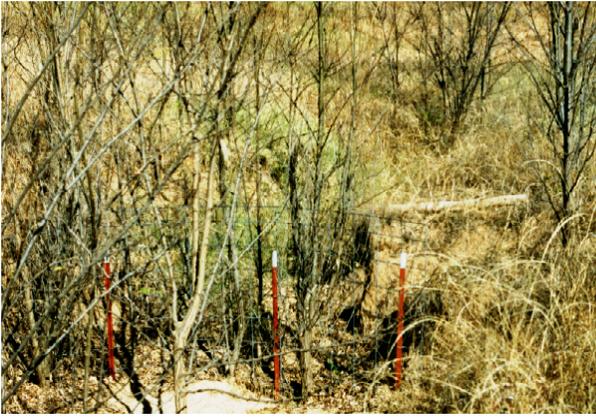
Figure 9c. Vegetative growth at the cattle panel location-winter following the 4th growing season

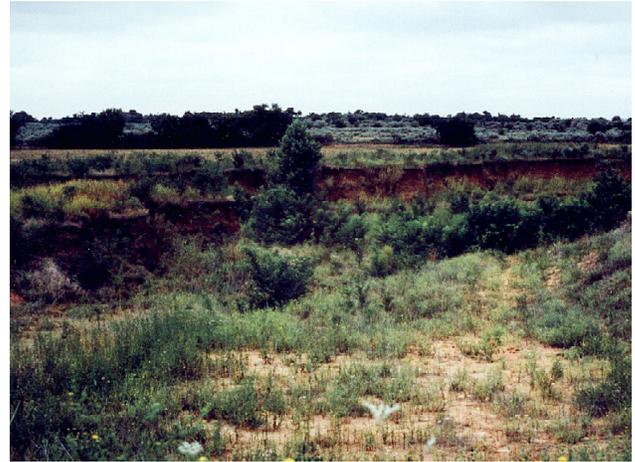
Figure 10a. Gully site and trees at age two

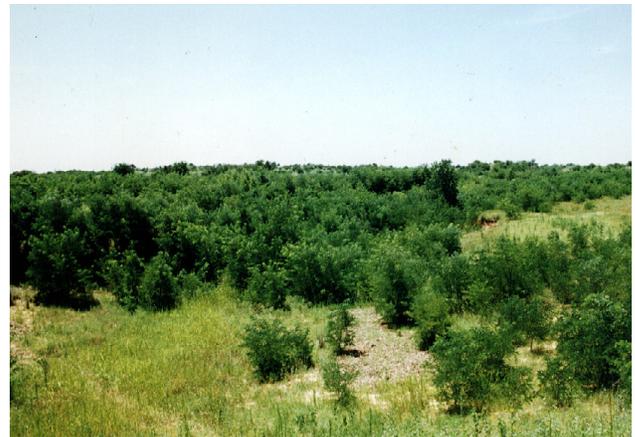
Figure 10b. Same view as in Figure 1 and 10a, in the sixth growing season

The results indicate the fiber mat and tree planting practices are effective where drainage areas are small (generally less than 5 acres) and conditions permit tree growth. The fiber mat provides initial erosion control and acts as a mulch to conserve moisture during the seedling establishment period.

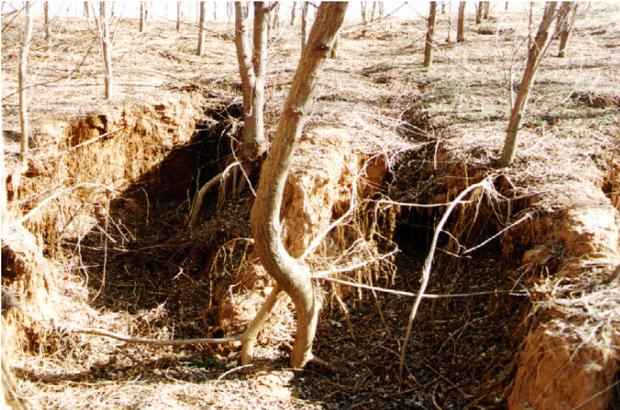
The black locust trees improve the microclimate for growth of grasses and other surface vegetation. Black locust, a legume, also benefits other plants by fixing nitrogen in the soil. Its root system, having numerous strong branching roots growing laterally and downward, is very effective in stabilizing banks

and limiting erosion (Figure 11). Typically, root lengths are several times the height of the tree. A stand of trees forms a network of branching roots.

Figure 11. View of black locust root system. The trees are 5 years of age, and 3 to 4 inches in diameter at the root collar.
