Forestry Note:

SIDE-GULLY CONTROL

Using Trees, Hand Labor, Rock and Other Materials

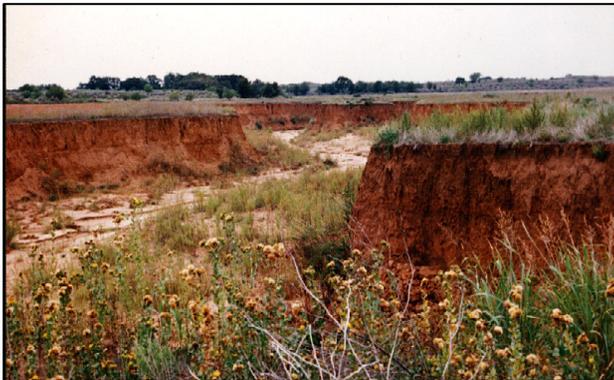
Figure 1. Large gully near Grandfield in Tillman County. This gully system is about 2 miles long, 70 feet wide and 18 feet deep at this location.

On large gully systems in deep sandy soils (Figures 1 and 2), lateral or side headcuts or overfalls frequently develop where small side drainages flow over the rim of the main gully. Where considerable runoff occurs, side gullies soon develop from these headcuts or overfalls. In such cases, control of the upper side gully as well as the headcut is needed.

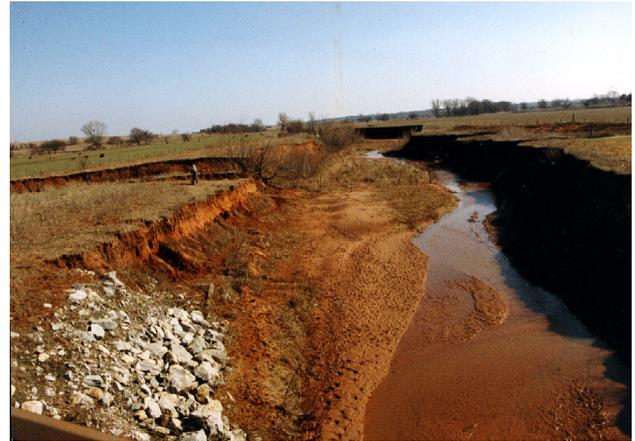
Figure 2. Large gully in McClain County caused by advance of a deep headcut in Stinson Creek channel

This example is located on the Stinson Creek gully system in McClain County (Figure 2). The side-gully outlet is in the right background of Figure 14a. This side gully is about 70 feet long and 15 feet deep at the outlet. The gully drains about 10 acres.

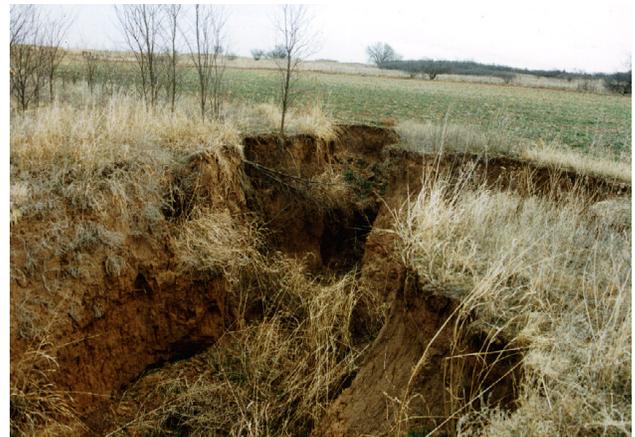
Figure 3. Side gully with sloughing sides and deep headcut on the Tillman County gully. This gully drains about three acres of the field in the background.

Because they are deep, these side gullies will continue to grow by sloughing and by headcut erosion (Figure 3), resulting in loss of soil and damage to streams and water quality. The main factor affecting growth is the size of the drainage area. Drainage areas for the side headcuts on the two gully systems vary from less than one to about 15 acres.

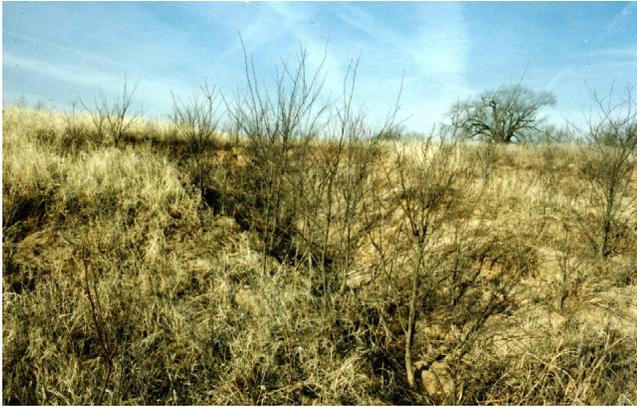
Figure 4. Small gully with shallow headcut in Tillman County controlled by applying fiber mat and planting black locust trees

Side gullies with small drainage areas and shallow headcuts can be controlled by a number of practices or practice combinations, including tree planting, livestock exclusion, diversion of runoff water, shaping and applying fiber mat and single cattle panel structures (Figures 4 and 5). (For information on these practices, see the video entitled *Gully Control Using Fiber Mat and Trees* and Forestry Notes on these techniques.)

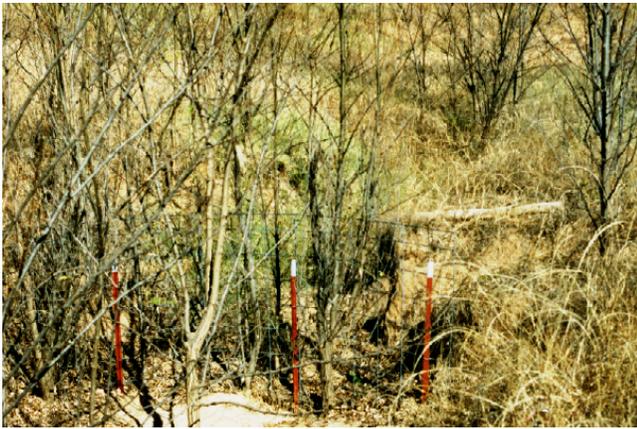
Figure 5. Lower part of a small gully on the Tillman County system, controlled by installing a curved cattle panel with T-posts and planting black locust trees

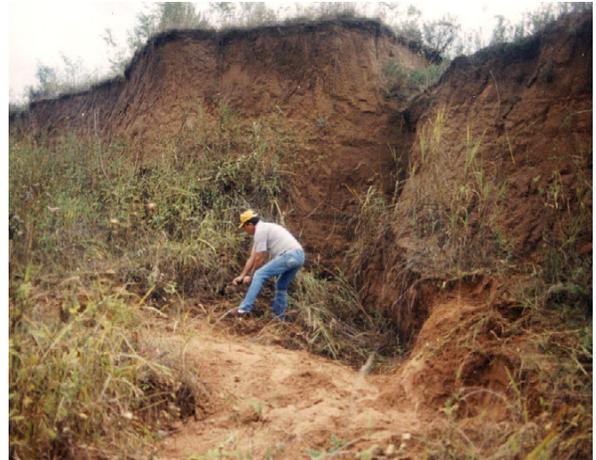
Figure 6a. Lower headcut of Example 1 side gully

This gully represents a typical condition, having a lower, deep headcut and shallow headcuts in the upper arms of the side gully (Figures 6a and 6b). The watershed area is about five acres in size.

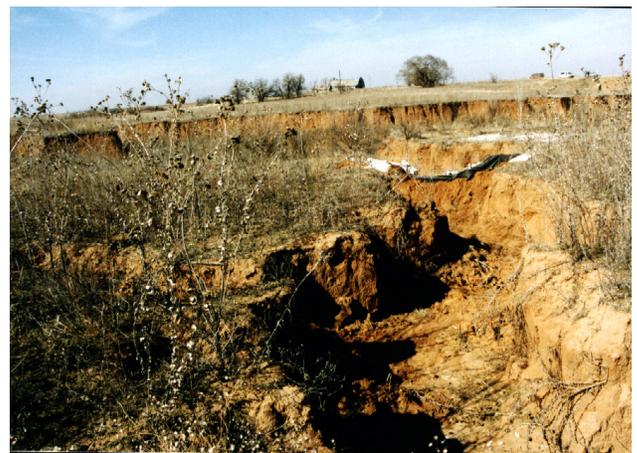
Figure 6b. Upper part of Example 1 side gully, looking toward the main gully

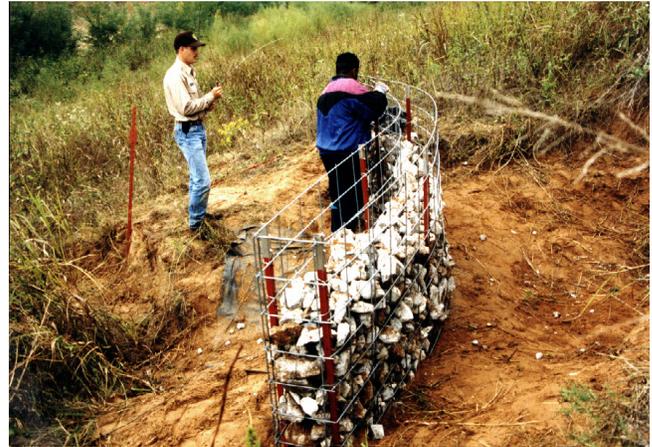
Figure 8a. Constructing the lower gabion drop structure

This gabion was constructed by placing two 4 by 16 foot cattle panels parallel and about 18 inches apart in a bowed or curved shape. The outside of the curve was positioned to face uphill. The panels were held in place by steel T-posts and tied together with wire to prevent them from separating (Figure 8a).

The space between the panels was filled with rock by hand labor. The rock purchased for the treatment was non-select riprap, 18 inches maximum diameter. Smaller rock in the range of about 6 to 8 inches maximum diameter were picked and placed by hand in the gabion.

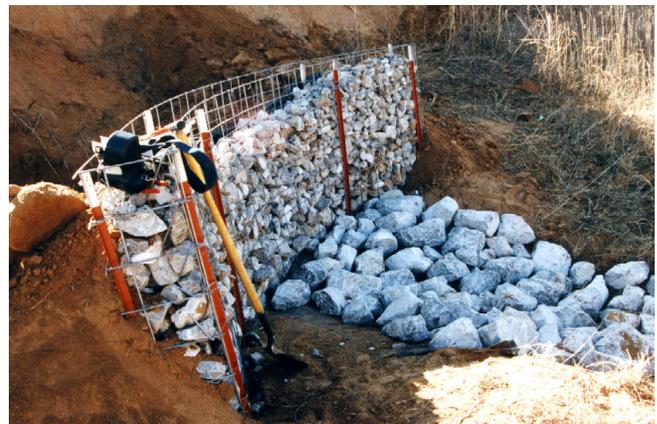
Figure 8b. Completed lower gabion with apron

The rock fill is lower in the middle of the gabion to provide a spillway for high flows. An apron of larger rock was placed below the gabion (Figure 8b). The upper side of the gabion is lined with geotextile fabric.

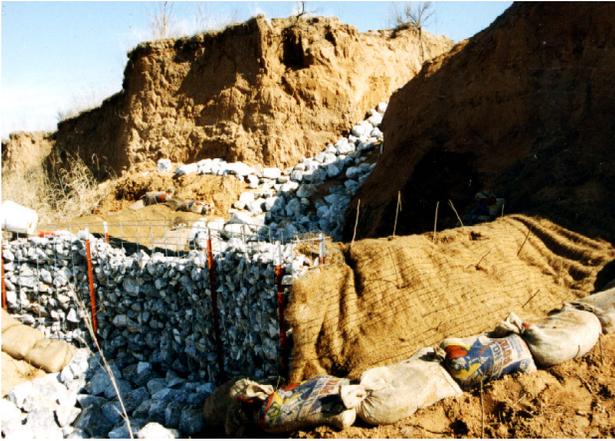
Figure 8c. Lower gabion with wing walls completed and black locust seedlings planted

Wing walls from the ends of the gabion to the main gully wall were constructed with soil, using shovels.

The wing walls were covered with burlap anchored by sandbags. The wing walls and surrounding area were planted with black locust seedlings at a close spacing (Figure 8c).

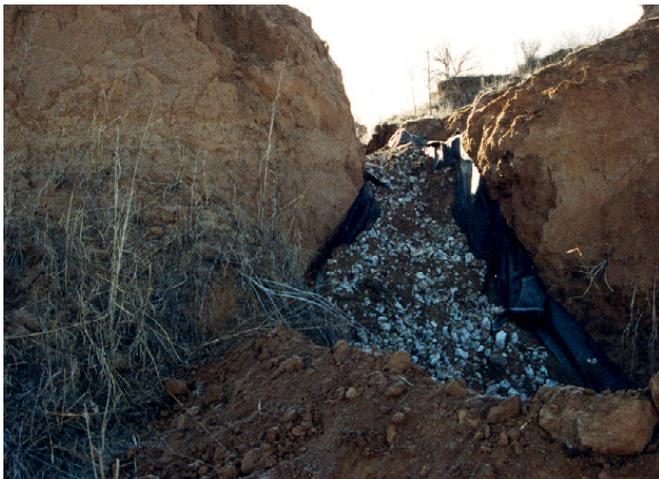
Figure 9a. Chute with geotextile fabric and small rock placed

The chute was constructed by first cutting down the lower headcut and gully sides, using shovels, to form a flat-sloping bottom. The slope of a chute structure should not exceed 1.5 to 1 (that is 1.5 feet of horizontal distance to a one-foot rise). The slope of the chute is 1.5 to 1 in the steepest part.

The entire chute area was lined with geotextile fabric before placing the rock. The fabric is necessary to prevent channeling of runoff water between and under the rocks causing failure of the chute. A six-inch layer of smaller rock was placed on the fabric with shovels (Figure 9a).

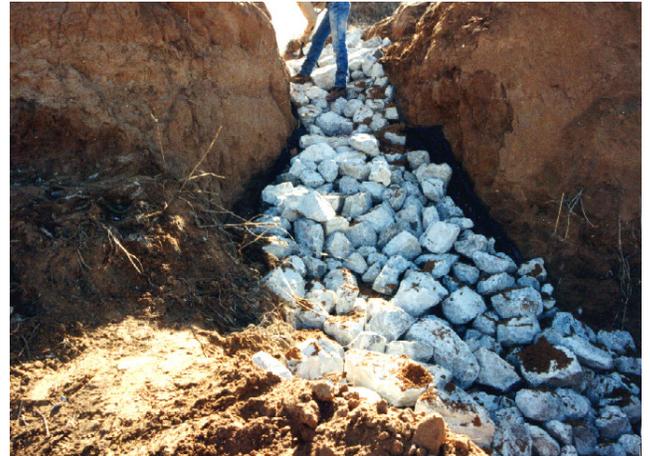
Figure 9b. Completed chute with large rock placed

Larger rocks ranging from about 8 to 18 inches maximum diameter were placed by hand to complete the chute (Figure 9b).

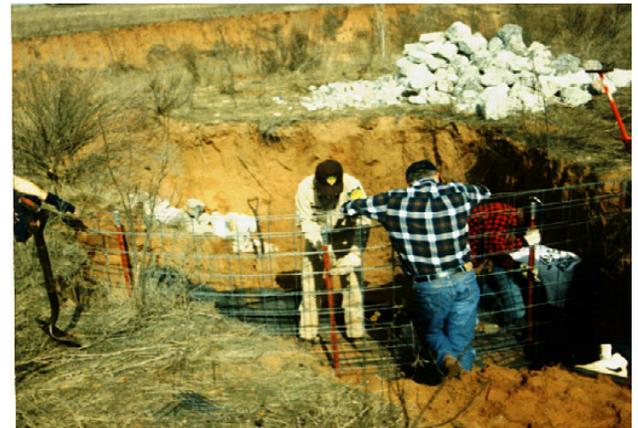
Figure 10a. Constructing the upper gabion

The upper gabion was constructed in the same way as the lower gabion. Notches were cut to tie the ends of the gabion into the gully walls (Figure 10a and 10b). Geotextile fabric was applied to the upper side of the gabion and gully bottom, and then was covered with soil (Figure 10c).

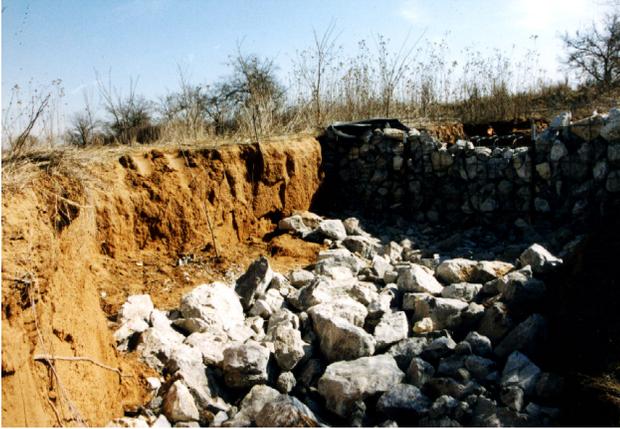
Figure 10b. Completed upper gabion and upper part of chute

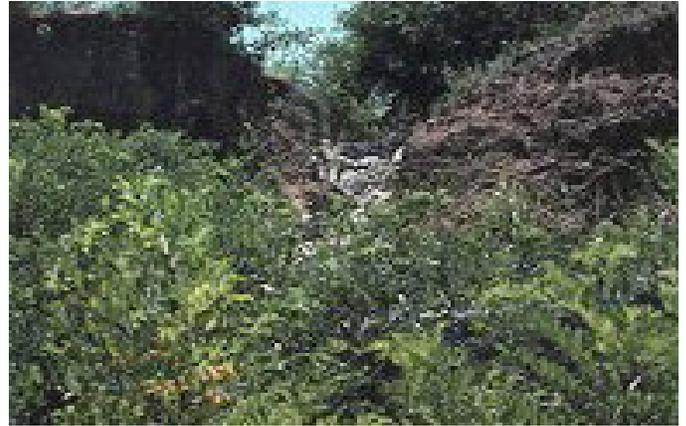
Figure 11a. Black locust tree growth around lower gabion, in the summer following planting

The treatment included the planting of black locust trees next to the structures and on the areas adjacent to the gully (Figures 11 a-11d). Figure 11a is a view of the black locust trees and other vegetation in the vicinity of the lower gabion in the summer following planting. Figure 11b is a view of the trees next to the lower gabion in the first winter following treatment. The growing season was favorable and almost all the seedlings survived.

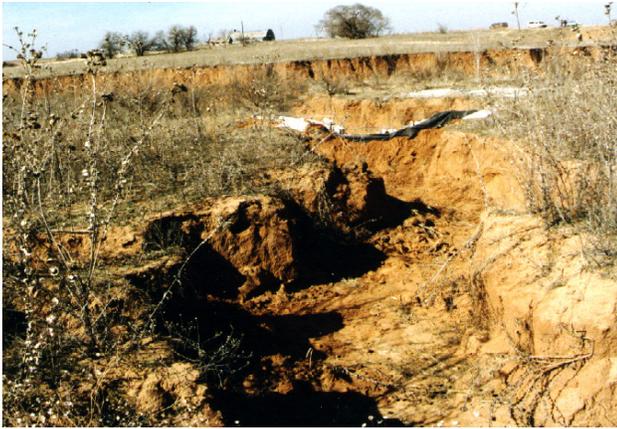
Figure 10c. Upper gully area and completed upper gabion. Note geotextile fabric and soil cover on the upper side of the gabion.

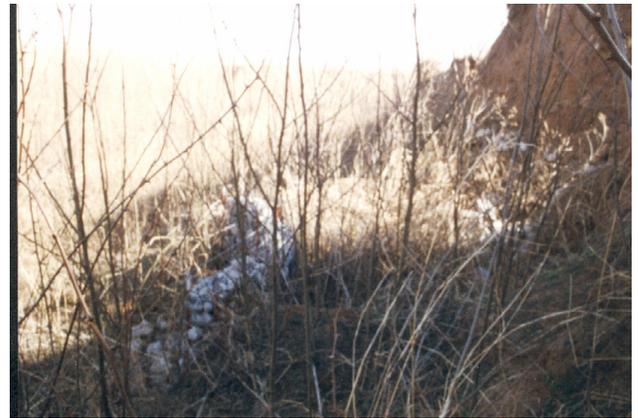
Figure 11b. Tree and other growth around lower gabion in the first winter

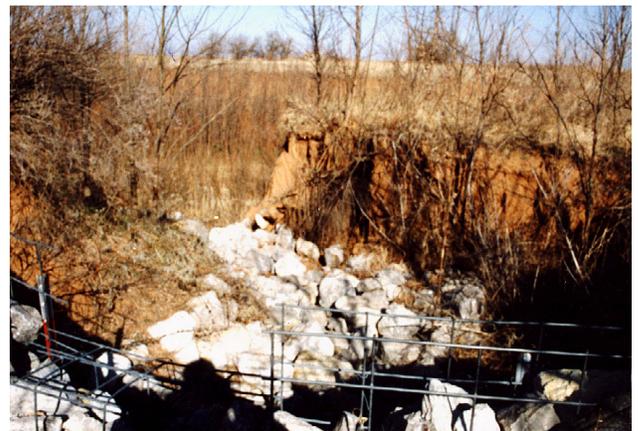
Figure 11c. Tree growth below upper gabion, in the first winter following treatment. The larger trees are 5 years old.

Figure 11d shows vegetative development and sediment build-up in the upper gully, in the winter following treatment. In Figure 11c, the tree plantings are 1 and 5 years of age. The upper, shallow headcuts will heal through continued sediment accumulation, vegetative growth and livestock exclusion.

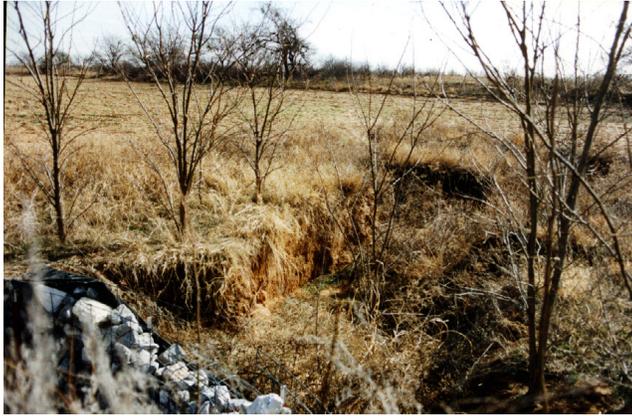
Figures 11d. Tree growth above upper gabion in the first winter following treatment. The larger trees are 5 years old.

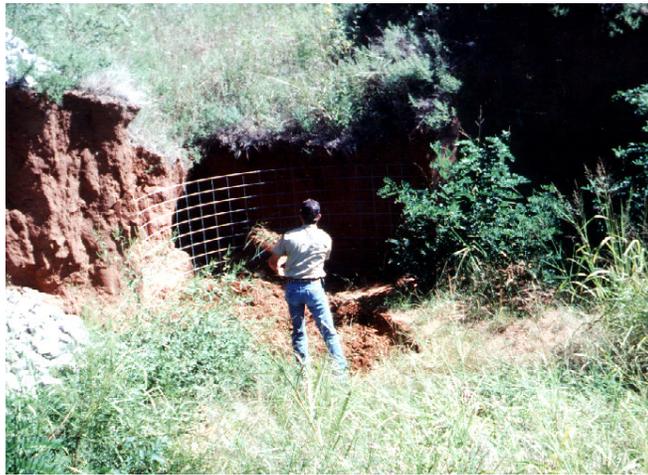
Figure 13a. Beginning construction on the Example 2 drop-structure

Using the design shown in Figure 12, a gabion drop-structure was installed below the headcut of a small branch of the Tillman County gully system (Figure 13a). The treatment consisted of shaping the gully bottom below the overfall with shovels, covering the shaped area with geotextile fabric and constructing a rock gabion and apron (Figure 13b). The gully is similar to the other two examples in general conditions of the overfall and the normal drainage. The overfall was about 5 feet in height. The normal drainage area was about 10 acres. However, the site differed from the other two examples in being subject to overflow through the emergency spillway of the main gully drop-structure.

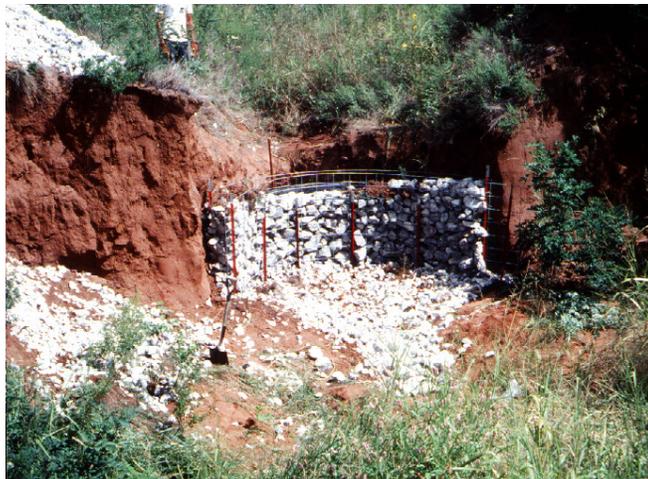
Figure 13b. Completed gabion drop-structure and apron

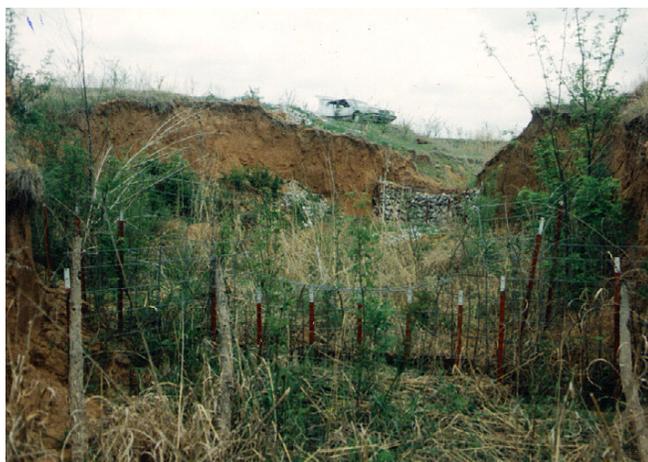
Figure 13c. Gully bottom control below the Example 2 drop-structure, constructed by placing cattle panels next to the gully sides and across the bottom. Photo was taken in the first growing season.

This structure was installed along with an additional gully bottom control and tree planting to stabilize this part of the gully system in order to handle occasional emergency spillway flows within the main structure design limits (Figure 13c).

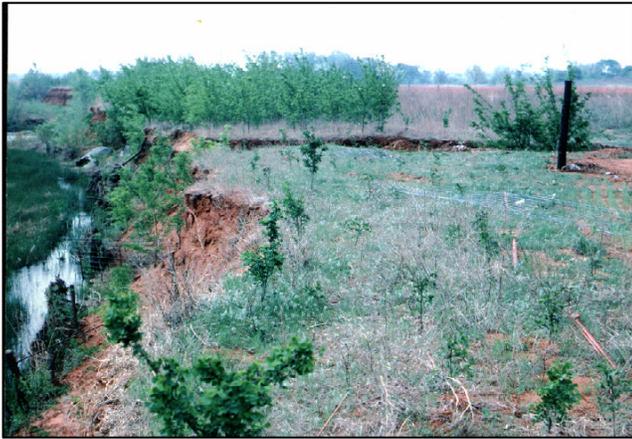
Figure 14a. Lower part of Example 3 side-gully on Stinson Creek system (at right side of photo). The plantings are first-year seedlings and trees in the third year of growth.

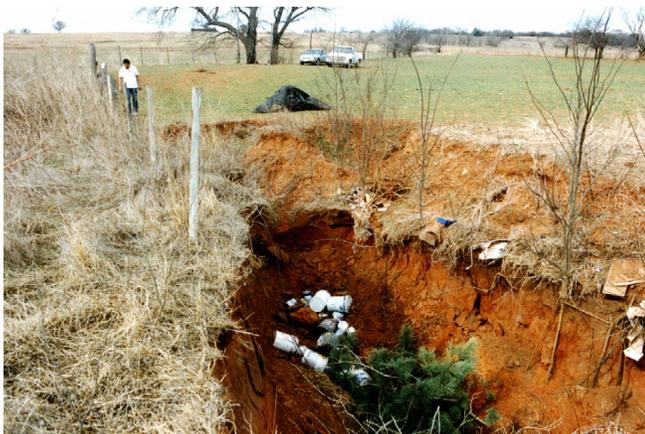
Figure 14b. Upper end of Example 3 side-gully showing headcuts in 2 steps. Note rooting characteristics of black locust in the gully wall.

The gully tapered to a two-step headcut (Figure 14b). The upper step was about 3 feet in height. The lower step was located about 20 feet from the upper step and was about 5 feet in height.

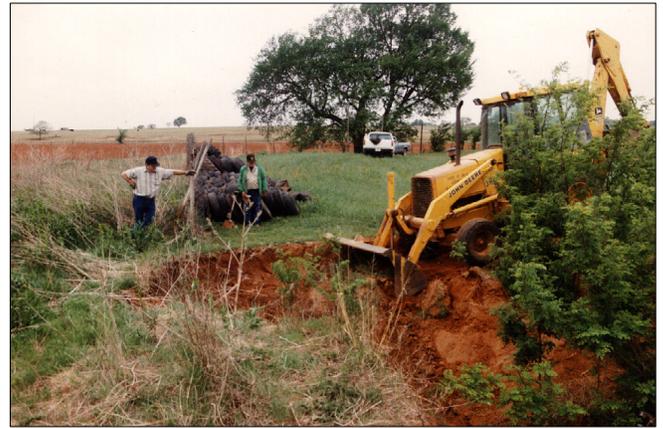
Figure 15a. First steps in construction on Example 3 were to shape and slope the upper gully area (note black locust saplings)

The chute area was shaped with a backhoe to a flat bottom with a slope of about 3 to 1 (Figures 15a and 15b). The shaped bottom was then covered with geotextile fabric (Figure 15c). The fabric is necessary to prevent channeling of runoff water underneath the rock surface. To prevent water from undercutting the chute, the edges of the fabric were buried to a depth of one foot on all sides.

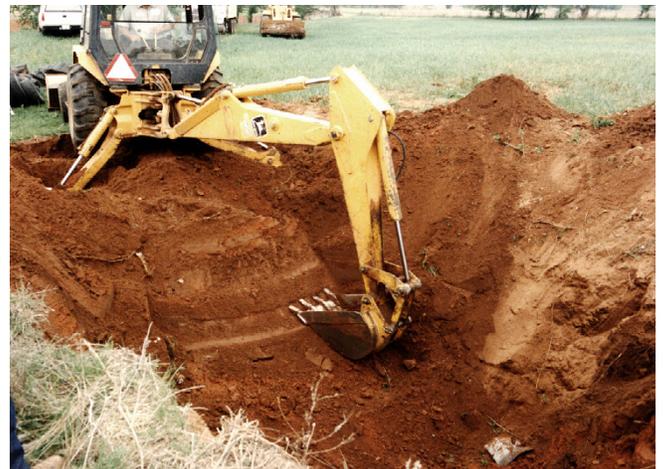
Figure 15b. The backhoe was used for final shaping

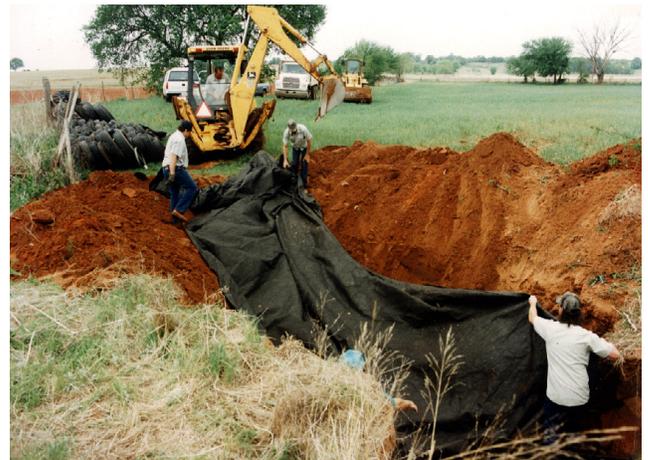
Figure 15c. Applying the geotextile fabric

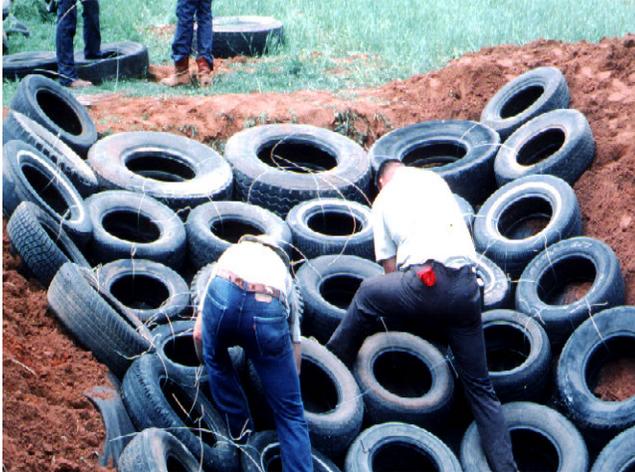
Figure 15d. Placing and wiring the tires

Used tires were then laid on the fabric and wired together (Figure 15d). A rock surface was applied over the tires by the bucket loader (Figure 15e). The rock material is non-select riprap with a maximum diameter of 12 inches. Figure 15f is the same view after rock application.

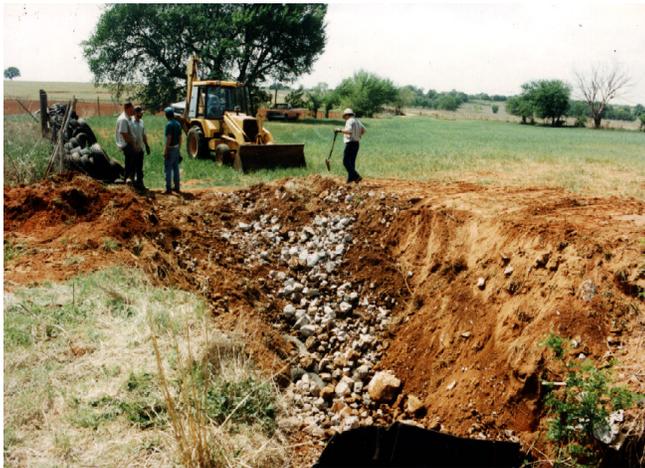
Figure 15e. Completed placement of rock

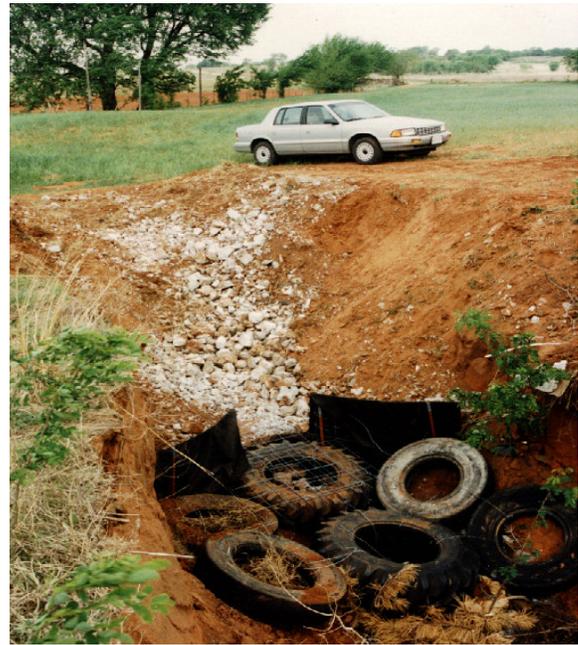
Figure 15f. Completed cattle panel structure and apron of tires

Old tractor and truck tires were placed to prevent undercutting of the toe of the chute (Figure 15f). The tires will soon be covered with soil. The gully and adjacent areas were planted with black locust trees.

The apron treatment includes a 4-foot by 16-foot cattle panel structure that was installed as part of a previous treatment design. The panel is not essential to this design, but will help hold the tires in place, promote soil accumulation and stabilize the gully bottom. The panel is curved upstream for added strength. It is held in place with T-posts. The panel is lined with geotextile fabric to trap sediment and promote vegetation. The tires were tied together and to the T-posts with wire.

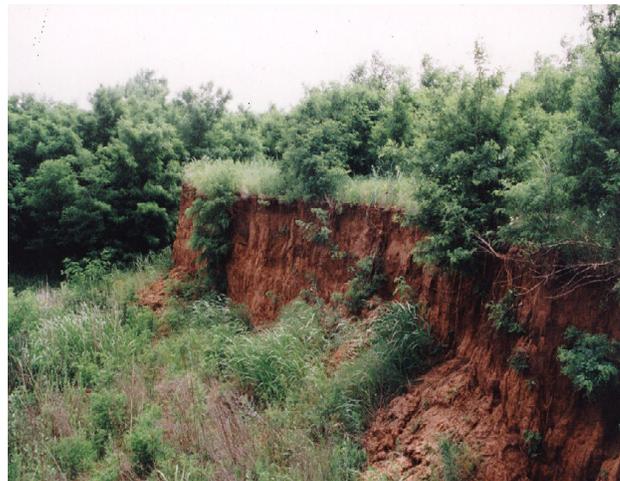
Figure 16a. Sprouting of exposed black locust roots

Black locust is particularly effective in erosion control because of its hardiness, drought resistance, high seedling survival rates, rapid growth and rooting characteristics. The rapid growth improves the microclimate for early development of grasses and other surface vegetation. Black locust, a legume, also benefits other plants by fixing nitrogen in the soil. Its strong branching root system is very effective in stabilizing banks and limiting erosion (Figures 16a and 16b). The trees typically develop large lateral and downward branch roots that are several times longer than tree height, and form a network of branch roots.

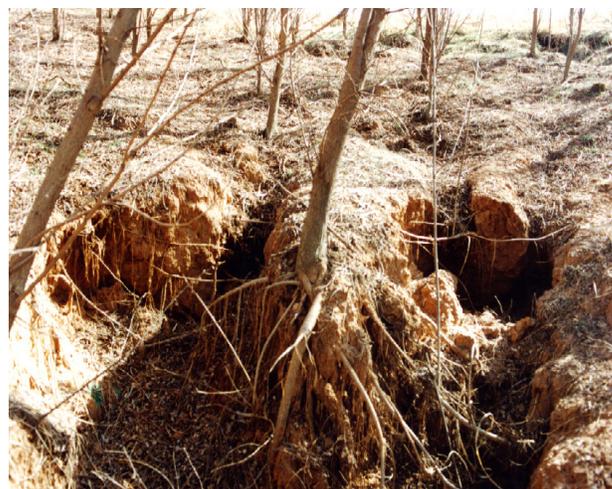
Figure 16b. Branching roots of a 5-year old black locust

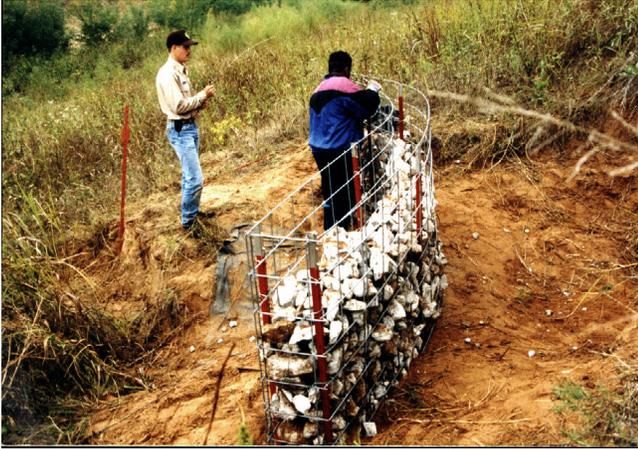
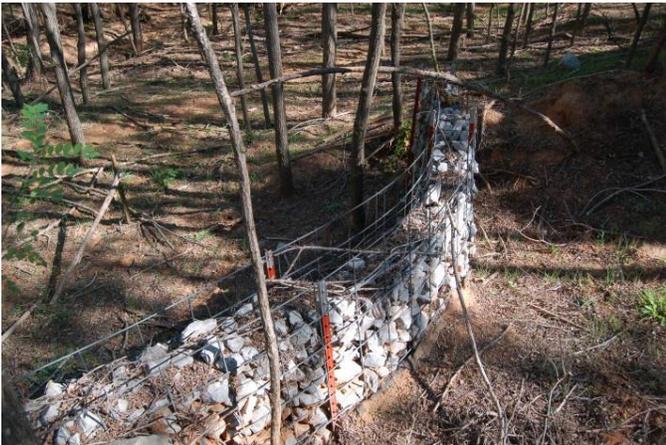
(Above) Lower gabion on Tillman County gully during construction in 1999

(Below) Same gabion in 2006

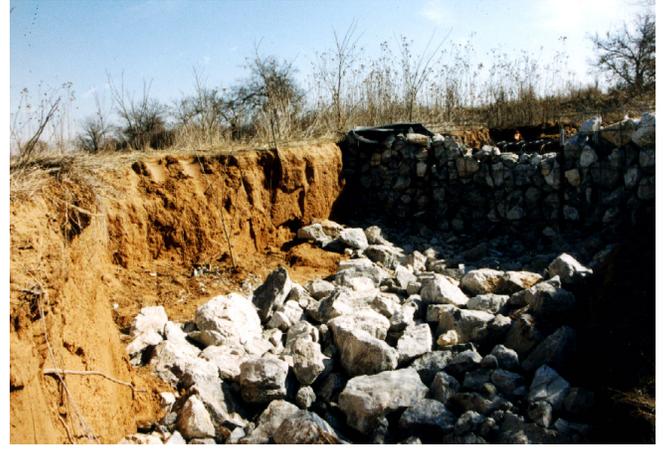
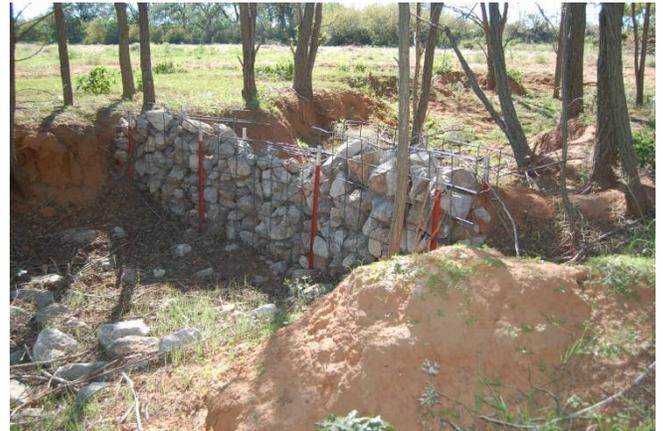
(Above) Upper gabion on Tillman County gully during construction in 1999

(Below) Same gabion in 2006
